DEPARTMENT OF TRANSPORTATION

Contract #: 04-0120F4Cty: SF/ALA Rte: 80 PM: 13.2/13.9File #: 1.28**WELDING INSPECTION REPORT****Resident Engineer:**Siegenthaler, Peter**Address:** 333 Burma Road**City:** Oakland, CA 94607**Report No:** WIR-022024**Date Inspected:** 16-Mar-2011**Project Name:** SAS Superstructure**OSM Arrival Time:** 700**Prime Contractor:** American Bridge/Fluor Enterprises, a JV**OSM Departure Time:** 1730**Contractor:** American Bridge/Fluor Enterprises, a JV**Location:** Job Site

Bridge No: 34-0006**Component:** Tower Grillage**Summary of Items Observed:**

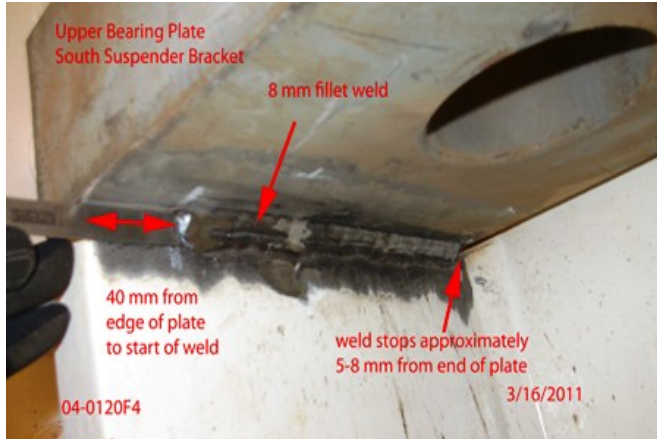
South Suspender Bracket:

This QA Inspector observed welding had been completed and was informed by QC Inspector Fred Von Hoff that he was waiting for the 48 hour period after welding to perform his final inspections. See photo below.
